GSEU WP2 TRAIN-THE-TRAINER COURSE

Case studies - Slovenia

Bridging the ABC System to UNFC

Slovenia case studies

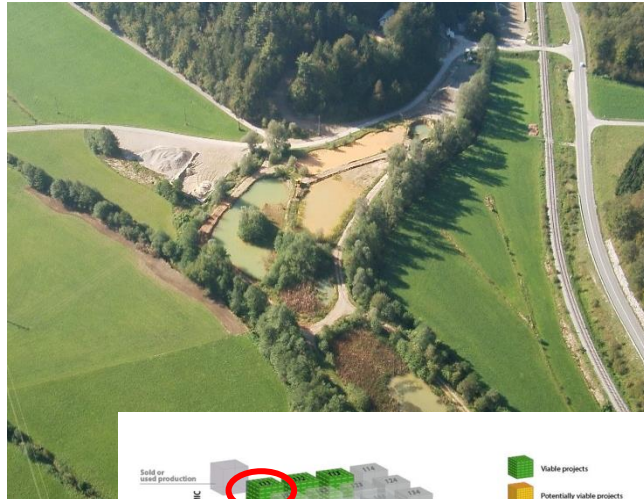
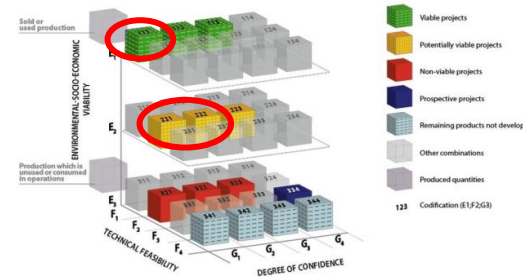
1- Active quarry of chert (SiO₂)

- ✓ mining right granted / all required permits are obtained,
- ✓ extraction and processing in “green manner”,
- ✓ use for refractories (products with high added value),
- ✓ “ABC” reserves are classified.

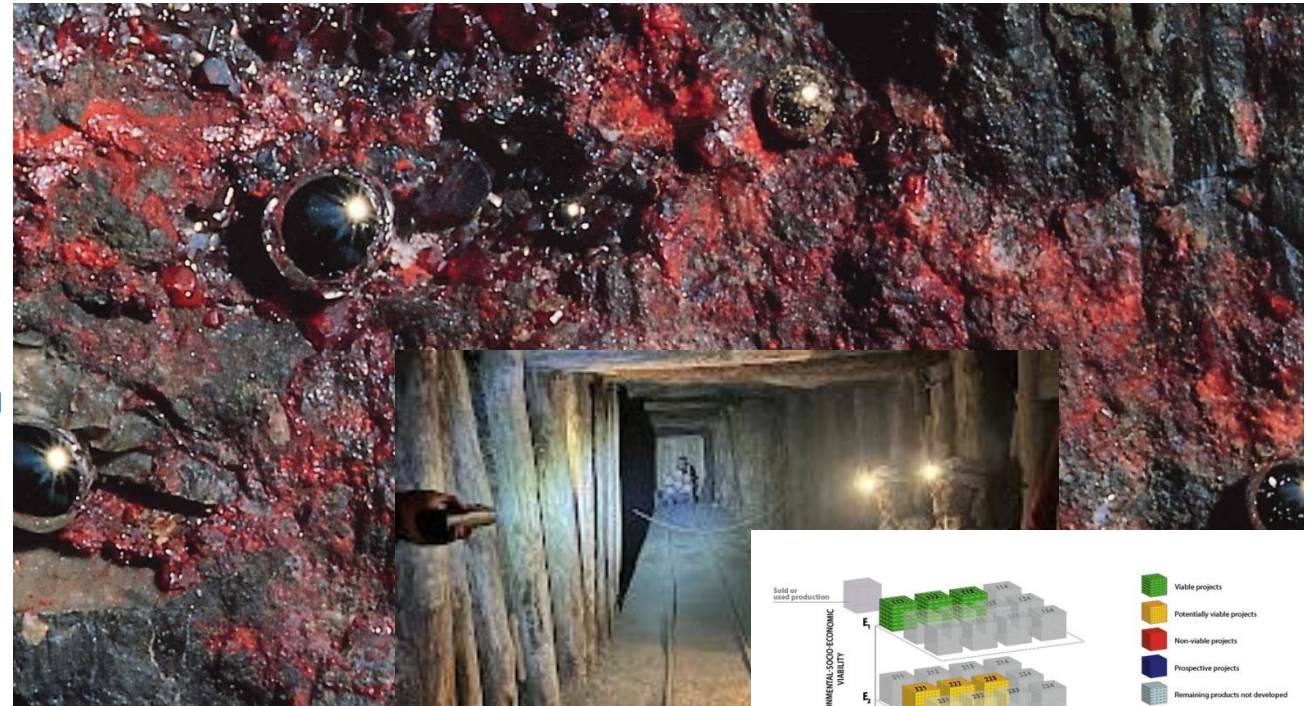
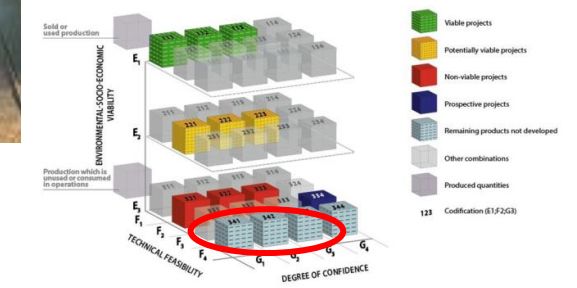
2 - Historical metal mine (Hg)

- ✓ mined for 500 years (since 1490),
- ✓ on UNESCO heritage list,
- ✓ mining museum,
- ✓ production stopped to toxicity for human and environment,
- ✓ mine is irreversible closed,
- ✓ “ABC” ore reserves remain in situ.

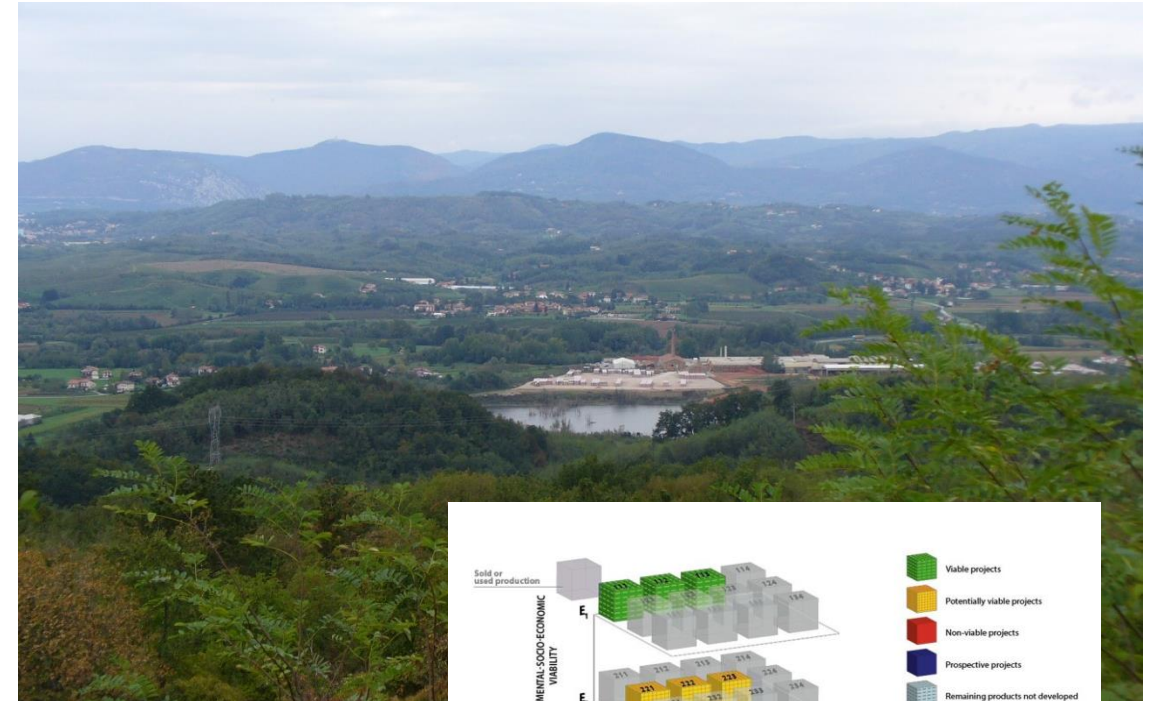
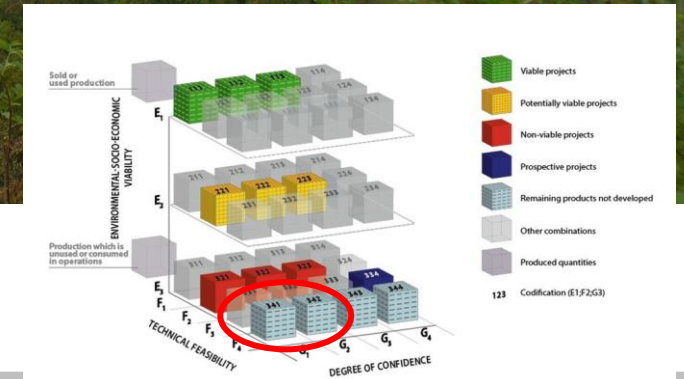
3 - Abandoned brick clay pit

- ✓ mining right expired, extraction was stopped,
- ✓ most of clay reserves are depleted,
- ✓ new clay-pit is open nearby, brick factory production goes on,
- ✓ remediation was completed into new habitat.
